## 1.0 INTRODUCTION

**Final 2020 HWM  
Control Strategy**

Map 2  
Berry Lake  
Oconto County, Wisconsin  
**2019-2020 Late-Season  
HWM Survey Results**

Berry Lake  
Oconto County, Wisconsin  
**2020 Compare:  
HWM Mapping  
vs PI Survey**

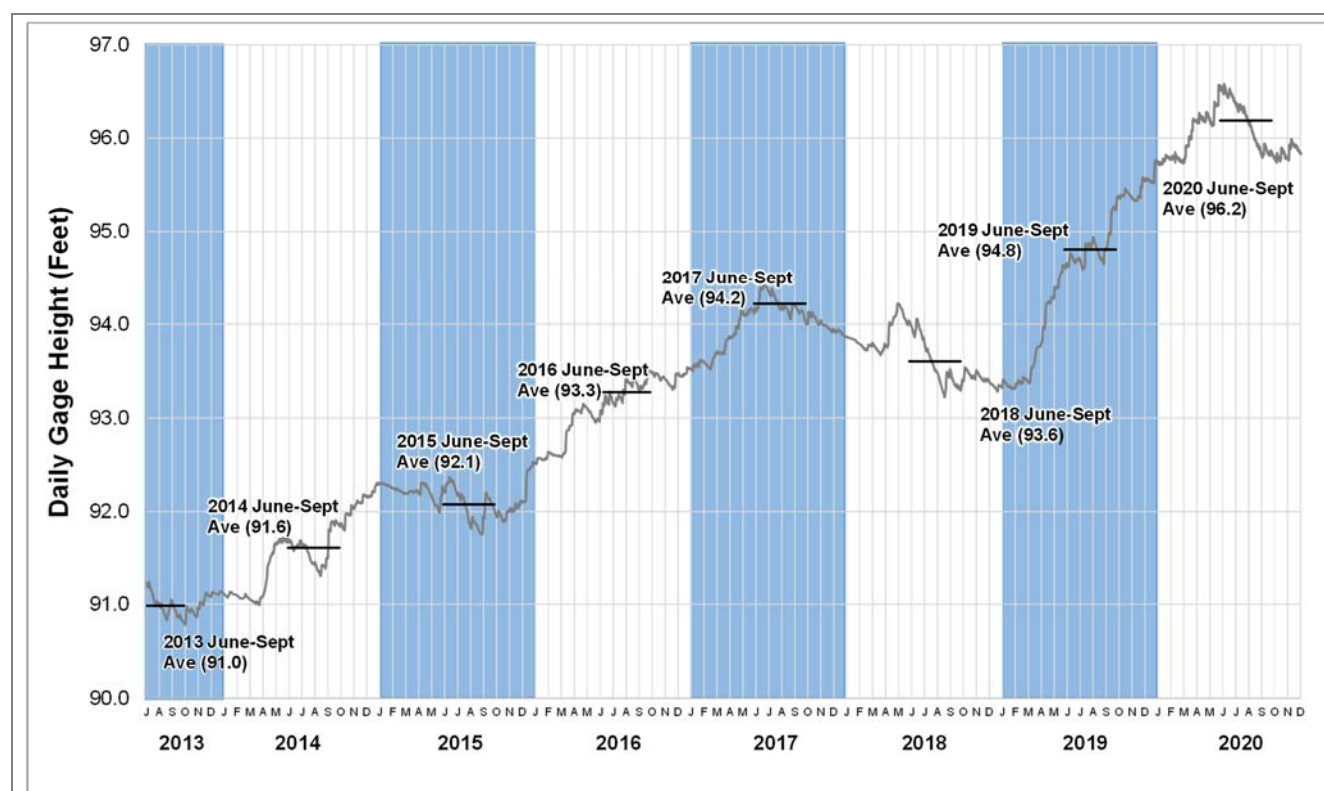
**Figure 1.0-1. Berry Lake water levels from July 2013 through December 2020.** Created using data obtained from the USGS Berry Lake water level monitoring station (USGS 2020).

Like many other seepage lakes in Wisconsin, Berry Lake experiences more dramatic fluctuations in water levels through time when compared to lakes that receive surface water inflow (drainage lakes). In the spring of 2013, the US Geological Survey (USGS) installed a continuous water level monitoring station on Berry Lake and it has been recording daily water levels almost continuously since July of 2013. Figure 1.0-1 displays the daily gage height from Berry Lake from July 3, 2013 to December 8, 2020. Water levels have trended higher in the years since the gauge was placed with water levels approximately five feet higher in late summer 2020 compared to 2013. Record rainfall in many parts of Wisconsin in 2019 and 2020 contributed to the relatively rapid increase in water depth in Berry Lake in recent years.

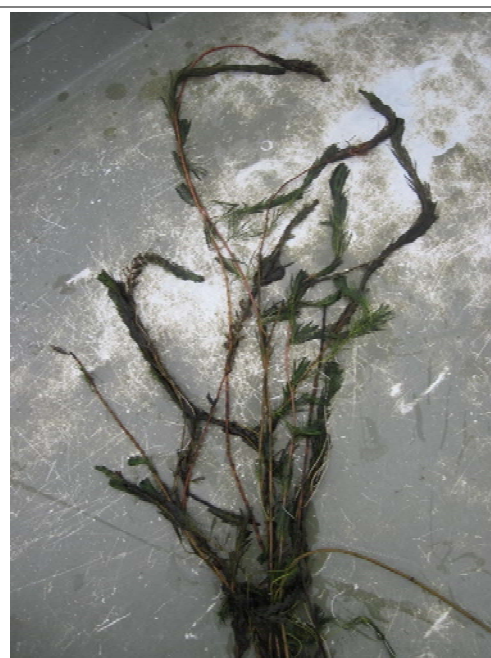
**Photo 1.3-1. EWM observed during a May 29, 2020 pre-treatment survey on Berry Lake, Oconto County.** Photo by Onterra, LLC

During the survey, actively growing EWM characterized by green growth was confirmed within the proposed treatment site. An underwater camera transect was completed through the targeted area which can be viewed on Onterra's YouTube webpage ([Click Here](#)). Surface water temperatures in the treatment area was 70°F. Water levels were higher than normal during the visit with much of the boat landing parking lot under water. The average depth of the treatment area was confirmed with a marked pole during the survey as well as through analyzing data from a USGS gauge station on the lake. Map 1 reflects the final treatment strategy using ProcellaCOR™ with an application rate of 4.0 product dosing units (PDU's) over one split treatment site totaling 10.0 acres.

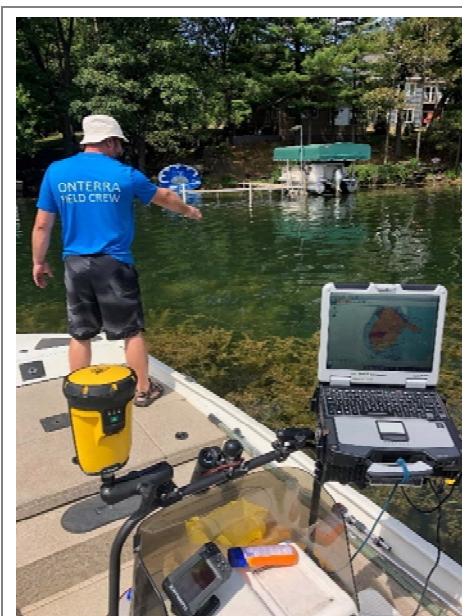
**Photograph 2.0-1. EWM mapping survey on Big Hills Lake, Waushara County.** Photo credit Onterra.

While the point-intercept survey is a valuable tool to understand the overall plant population of a lake, it does not offer a full account (census) of where a particular species exists in the lake. During the HWM mapping survey, the entire littoral area of the lake is surveyed through visual observations from the boat (Photography 2.0-1). Field crews supplemented the visual survey by deploying a submersible camera along with periodically doing rake tows. The HWM population is mapped using sub-meter GPS technology by using either 1) point-based or 2) area-based methodologies. Large colonies >40 feet in diameter are mapped using polygons (areas) and are qualitatively attributed a density rating based upon a five-tiered scale from *highly scattered* to *surface matting*. Point-based techniques were applied to AIS locations that were considered as *small plant colonies* (<40 feet in diameter), *clumps of plants*, or *single or few plants*.

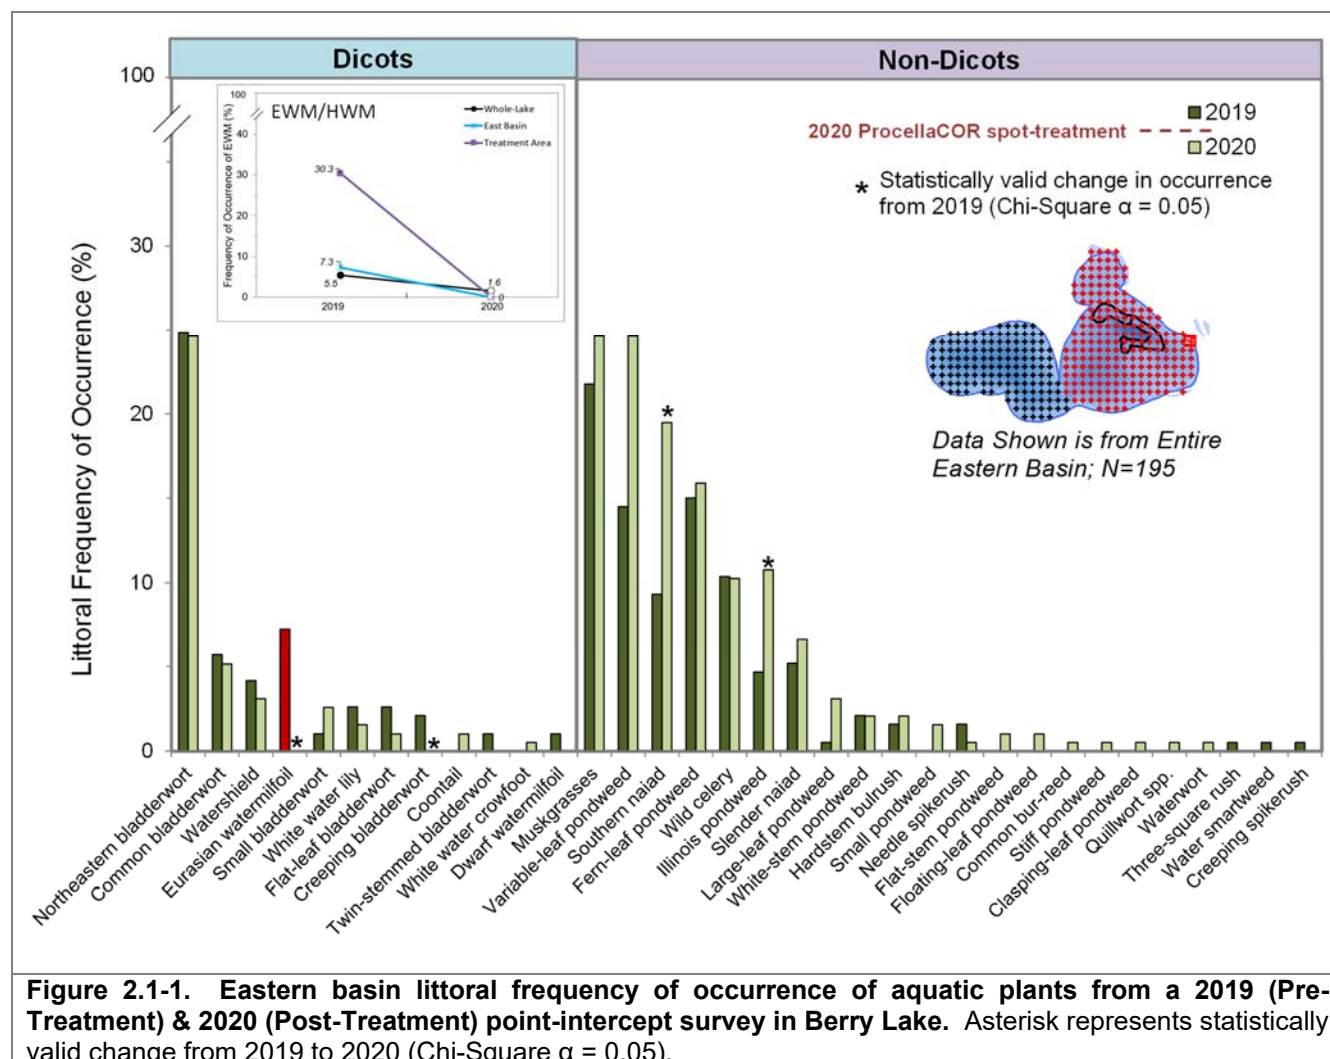
Figure 2.1-1 displays the littoral frequency of occurrence of aquatic plant species located in the eastern basin of Berry Lake during the 2019 and 2020 point-intercept surveys. The littoral frequency of occurrence of HWM exhibited a statistically valid 100% decrease in from 2019-2020 and was not located at any of the 195 sampling locations in 2020. Creeping bladderwort (*Utricularia gibba*) was the only native aquatic plant species to show a statistically valid decrease in occurrence between the two surveys. Creeping bladderwort is a very small, free-floating species that is susceptible to wind driven water movement and is most common in shallow waters, often amongst floating-leaf plant communities. All remaining native species in the survey area were statistically unchanged in occurrence between the two surveys with the exception of southern naiad (*Najas guadalupensis*) and Illinois pondweed (*Potamogeton illinoensis*) which exhibited a statistically valid increase in occurrence (Figure 2.1-1).

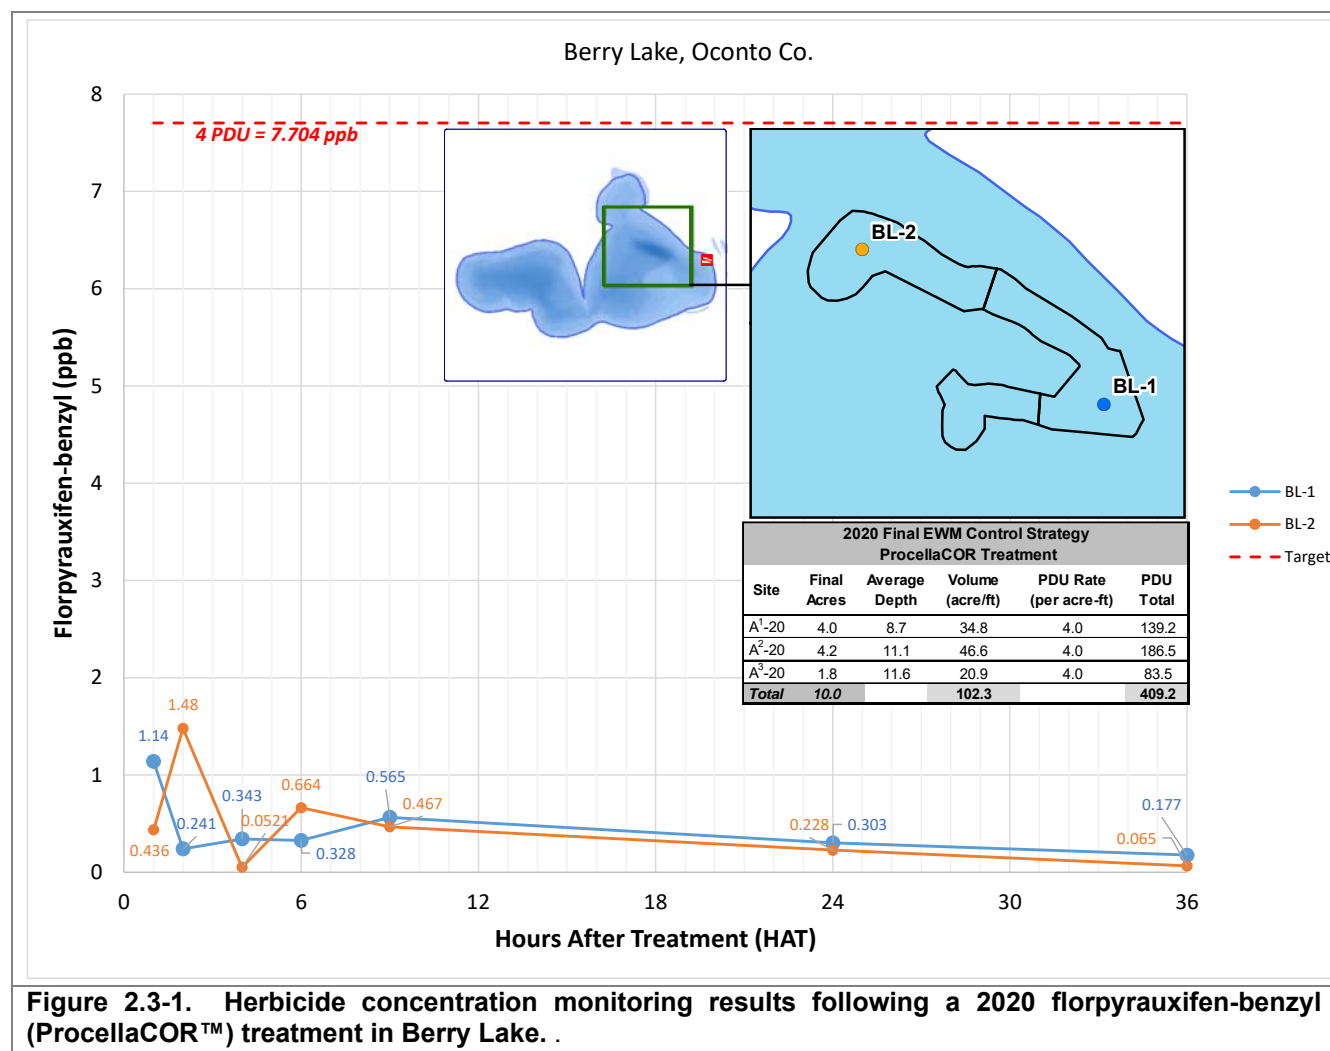
Figure 2.3-1 displays the results of the post-treatment herbicide concentration monitoring. The application rate is converted to parts per billion of florpyrauxifen-benzyl and is displayed as a dashed red line on the graph. The measured concentrations of herbicide were consistently well below the application rate of 7.704 ppb. The concentrations were somewhat variable between the two monitoring sites in the first six hours after treatment and from 9 HAT to 36 HAT were measured at nearly the same concentrations between sites (Figure 2.3-1). Low, but detectable amounts of herbicide were detected in the last sampling interval collected 36 HAT.

The herbicide concentration data collected after treatment is somewhat difficult to interpret in a traditional sense in terms of a concentration exposure time necessary to achieve HWM control. In the 2020 treatment in Berry Lake, measured flupyraxifen-benzyl concentrations were all less than 1.5 ppb and were well below the application rate of 7.7 ppb in every sampling interval, and yet a high level of HWM control was observed. Compared to several other projects that Onterra monitored in 2020 that also conducted post-treatment ProcellaCOR™ concentration monitoring, the measured amount of active ingredient in Berry Lake during the earliest sampling intervals (1 HAT, 2 HAT) were amongst the lowest in any project, likely because of the exposed nature of this treatment site.

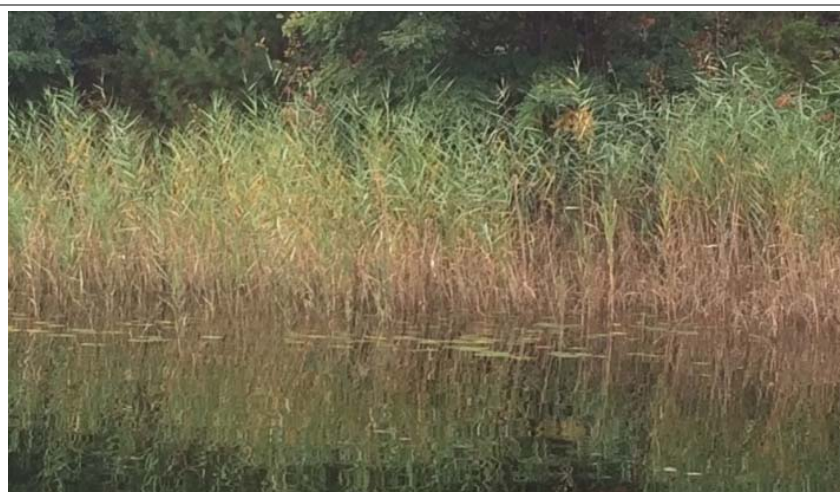
**Photo 2.4-1. Common Reed (*Phragmites australis*) observed growing in Berry Lake during a 2014 survey. (Photo by Onterra, LLC)**

During a 2014 survey, Onterra ecologists documented the presence of another non-native species found in Wisconsin; common reed (Photo 2.4-1). Common reed (*Phragmites australis* subsp. *australis*) is a tall, perennial grass that was introduced to the United States from Europe. A native strain (*P. australis* subsp. *americanus*) of this species also exists in Wisconsin and the plant material collected from Berry Lake in 2014 was sent to the UWSP herbarium where it was later confirmed to be

of the non-native variety. This species can form towering, dense colonies that overtake native vegetation and replace it with a monoculture that provides inadequate sources of food and habitat for wildlife.

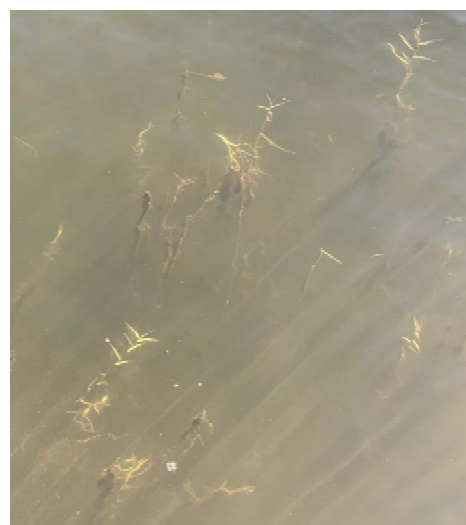
**Photo 2.4-2. Common Reed (*Phragmites australis*) observed growing in Berry Lake during 2020 survey.** (Photo by Onterra, LLC)

The rising water levels in Berry Lake in recent years may be causing the common reed to struggle to thrive, however the plants observed in 2020 appeared to be actively growing despite being largely submerged.

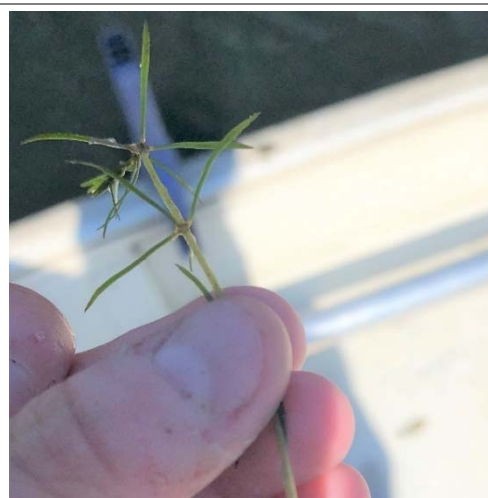
**Photo 3.0-1. EWM observed during a July 24, 2020 survey on Berry Lake, Oconto County. Photo by Onterra, LLC**

While conducting the whole-lake point-intercept survey on July 24, 2020, the survey crews encountered HWM in the western basin exhibiting obvious signs of stress in the form of fused leaflets and deformed growth (Photo 3.0-1). It is suspected that these characteristics were caused by exposure to ProcettaCOR™ that dissipated beyond the application area at a level that injured the plants rather than at levels sufficient to cause plant mortality. Onterra encountered similar apparently injured milfoil in several other lakes in 2020 in a similar treatment scenario in that the injured plants were well outside of the targeted area of the lake. It is unknown whether the HWM reductions observed in the eastern basin of Berry Lake in 2020 will be sustained through the 2021 growing season. The possibility exists that some HWM in Berry Lake may have been injured by the 2020 herbicide treatment, but root crowns may have survived and could rebound with new growth during 2021.

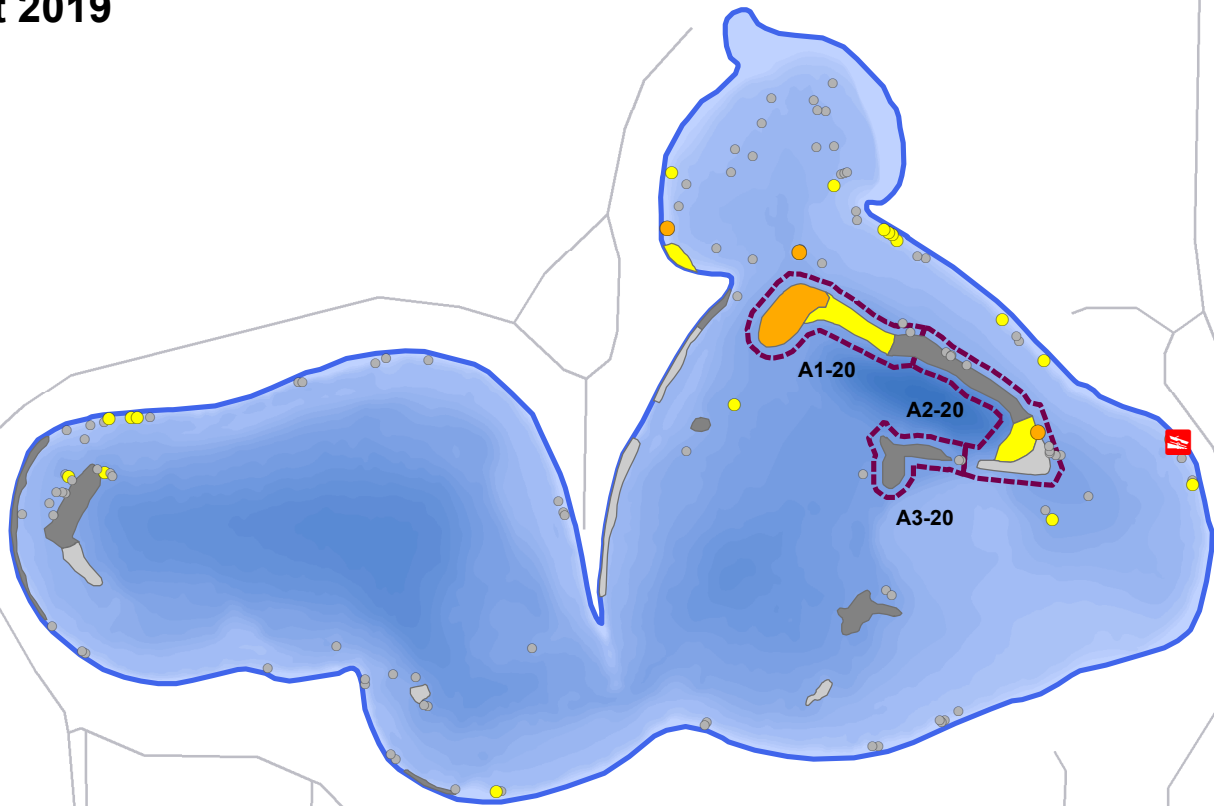
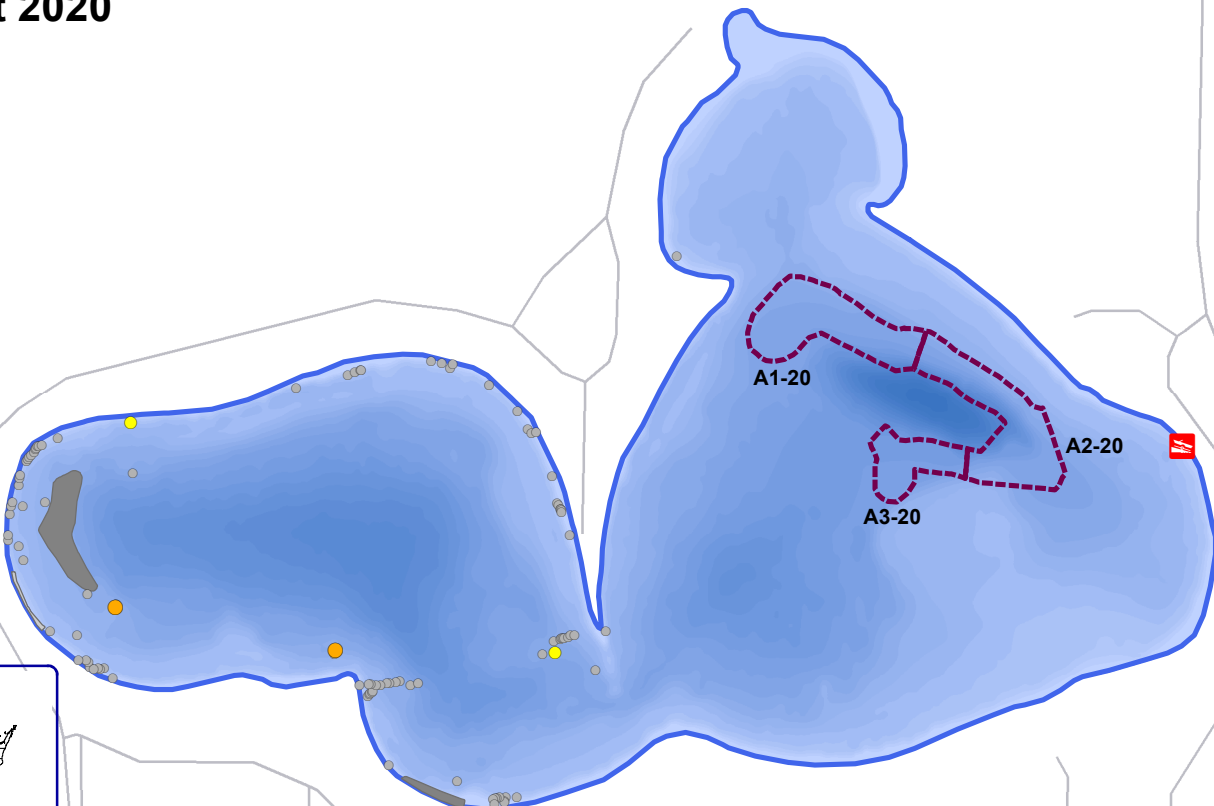
# August 2019

# August 2020

The Late-Summer HWM Mapping Survey is a meander-based survey conducted when the plant is at its peak growth stage, allowing for a true assessment of the amount of this exotic within the lake. All HWM encountered were mapped with a sub-meter GPS using either points or polygons. Large colonies over 40 ft in diameter were mapped using polygons, while *small colonies*, *clumps of plants*, and *single plants* would be mapped using points. Colonies marked with polygons were attributed a density rating using a 5-tiered density scale from *highly scattered* to *surface matting*. Late-summer HWM mapping surveys have been conducted annually on Berry Lake since 2012. The 2019 Late-Summer Mapping Survey represents the pre-treatment HWM population prior to the 2020 herbicide treatment. The 2019 survey found 8.6 acres of colonized HWM in Berry Lake of which the largest and densest concentration of plants was within the eastern basin (Map 2, top frame).

Onterra ecologists conducted the Late-Summer HWM Mapping Survey on Berry Lake on August 18, 2020, corresponding to approximately eight weeks after the herbicide treatment. The results of the survey are displayed on the bottom frame of Map 2. The survey crew put extra focus within the 2020 herbicide treatment area and supplemented the visual meander survey with the use of a submersible camera. The crew located just one single HWM plant in the entirety of the eastern basin of Berry Lake,

and no HWM was located in the vicinity of the herbicide treatment (Map 2, bottom frame). A modest HWM population, was located in the western basin and included a *scattered* colony on the far west end of the lake, and a few narrow strips of plants growing near shore in shallow waters of the west basin (Map 2, bottom frame). The HWM population in the western basin was of a similar overall footprint between 2019 and 2020.

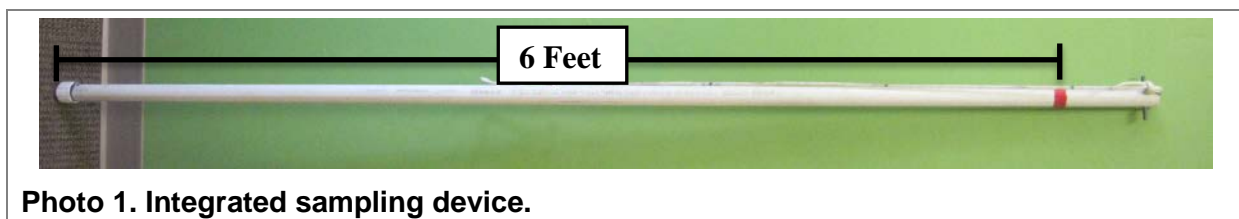
All water samples will be collected using an integrated sampler (Photo 1). A video tutorial demonstrating the proper sample collection methodology is available on Onterra’s YouTube web page: <https://www.youtube.com/channel/UCHj5OSdj1axlA9NYuXRXybw>.

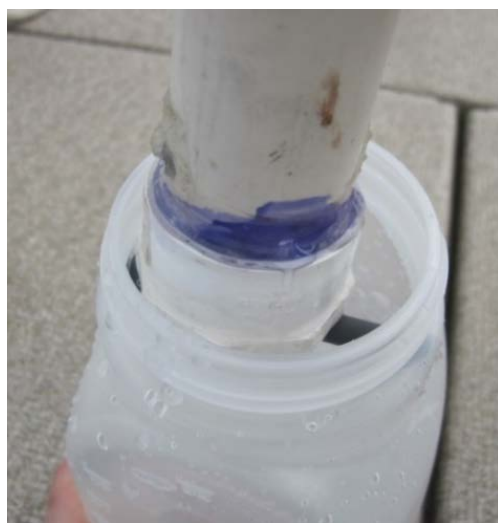
**Photo 2. Emptying the water sample from the integrated sampler device into the custom mixing bottle.**

It is important to rinse the integrated sampler and the custom mixing bottle with the water from each sampling site upon arrival at the site. Water is collected by pushing the integrated sampler straight down to a depth of six feet; or in water shallower than six feet, down to approximately one foot above the bottom sediment. The sampler is brought to the surface and emptied into a customized mixing bottle by pushing open the stop valve at the end of the integrated sampler (Photo 2). Water from the custom mixing bottle should be used to triple rinse the clear glass bottle. After the clear glass bottle is triple rinsed, it is to be filled for a fourth time with the water from the custom mixing bottle and then carefully poured into the brown glass bottle which has a preservative solution already inside (Photo 3). The sticker on the brown glass bottle must be appropriately labeled with the site label and time interval for which the sample was collected (Example: BL1, 1 HAT). The final sample (in the brown bottle) as well as the emptied clear glass bottle should be carefully placed within the provided bubble wrapped pouch to protect from accidental breakage.

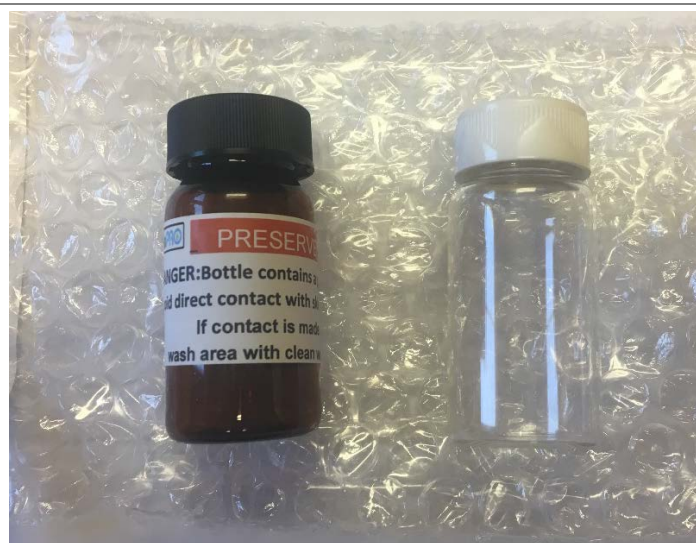
**Photo 3. Clear glass mixing bottle and final brown glass bottle.**

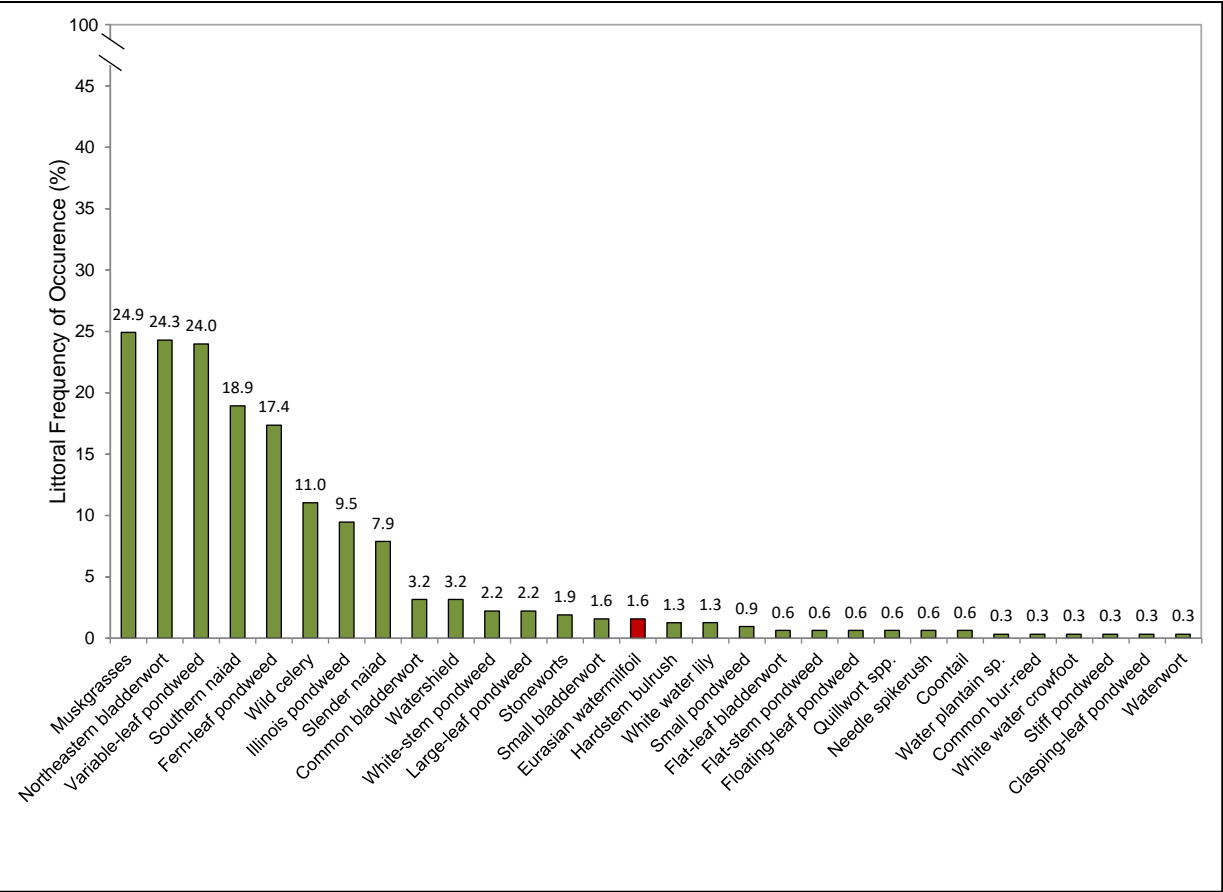
**Littoral Frequency of Occurrence of Aquatic Plants from a 2020  
Whole-Lake Point-Intercept Survey in Berry Lake.**

Littoral Frequency of Occurrence of aquatic plants from a 2020 whole-lake point-intercept survey in Berry Lake.
