1.0 INTRODUCTION

Berry Lake, Menominee and Oconto Counties, is a seepage lake with a maximum depth of approximately 23 feet. This mesotrophic lake has a relatively small watershed when compared to the size of the lake. Four exotic plant species, pale-yellow iris, reed canary grass, common reed, and Eurasian watermilfoil are known to exist in Berry Lake. The primary citizen-based organization leading management activities on Berry Lake is the Berry Lake Property Owners Association (BLPOA).

**May 2019 HWM Survey
Results & Final Hand-
Harvesting Strategy**

Map 2
Berry Lake
Oconto County, Wisconsin
**Late-Summer 2019
EWM/HWM Survey Results**

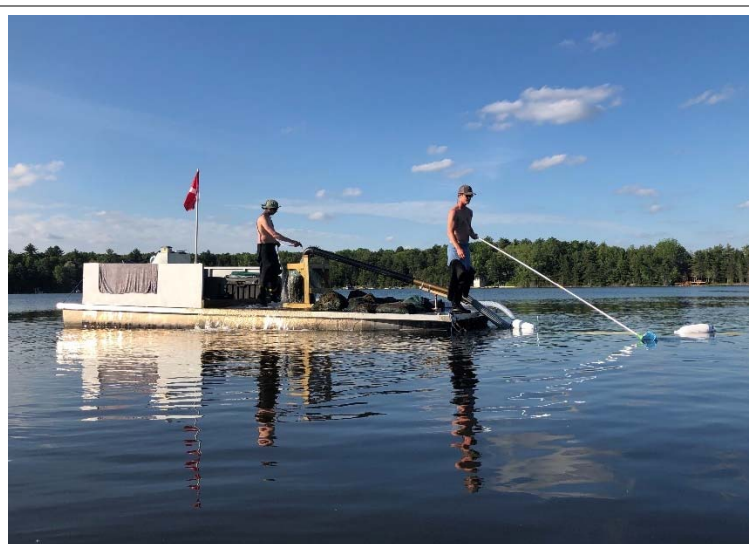
Photo 2.2-1. AIS removal specialists from Aquatic Plant Management, LLC work to harvest HWM from Berry Lake.
(Photo provided by BLPOA)

The BLPOA contracted with Aquatic Plant Management, LLC (APM) in 2019 to provide professional hand-harvesting services of HWM. AIS removal specialists from APM completed DASH services over five days between June 17 and July 2, 2019, harvesting approximately 253.5 cubic feet of HWM from Berry Lake (Table 2.2-1, Photo 2.2-1). The largest amount of harvest was from site E-19 in which 147 cubic feet of HWM was removed. Divers noted that much of the HWM consisted of relatively short plants and that HWM was auto-fragmenting at all sites. No harvesting efforts took place within site A-19 (Not shown on Table 2.2-1). Modest amounts of native plant by-catch consisting of pondweed species were reported by APM. A summary report of the DASH activities completed in 2019 authored by APM, LLC is included as Appendix A.

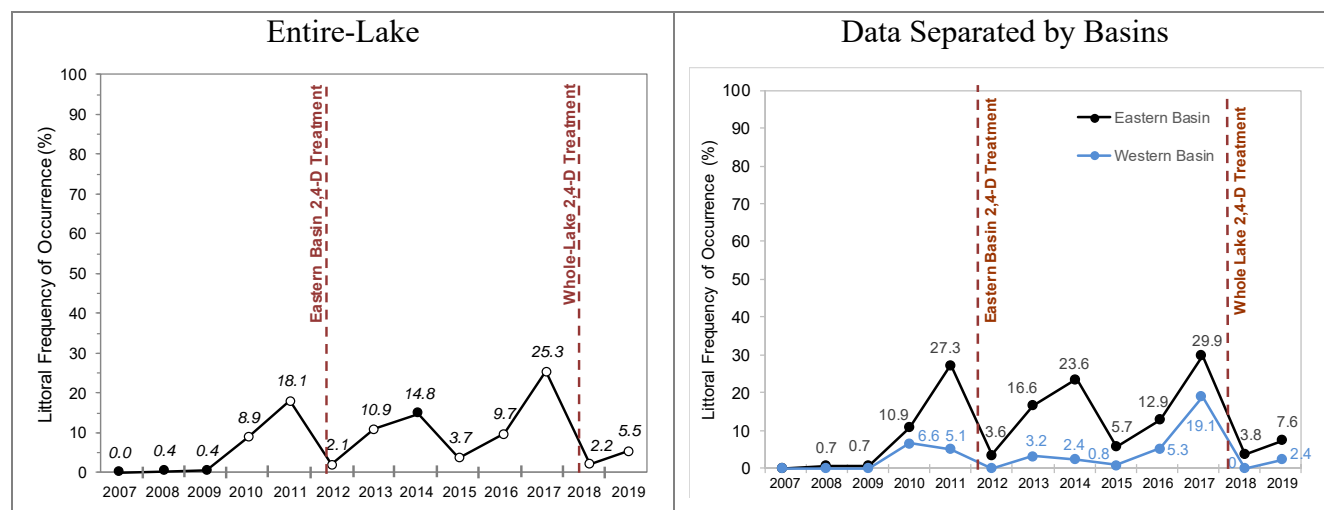
Figure 2.4-1. Berry Lake HWM littoral frequency of occurrence from 2007-2019. Open circles on left figure represent a statistically valid change from previous survey. .

The HWM population increased to the highest level since monitoring began at 25.3% in 2017 (Figure 2.4-1, left frame), with almost 30% of littoral sampling locations in the eastern basin and 19% in the western basin containing HWM (Figure 2.4-1, right frame). Following the 2018 whole-lake 2,4-D treatment, the lake-wide littoral frequency of occurrence of HWM was reduced to 2.2%, representing a 92% reduction since 2017. Separating the data by basin, the littoral frequency of occurrence of HWM was reduced to 0% (100% decline) in the western basin, whereas the occurrence was reduced to 3.8% (87% decline) in the eastern basin (Figure 2.4-1 right frame). Continued monitoring during 2019 indicated that the lake-wide HWM littoral frequency of occurrence increased to 5.5%.

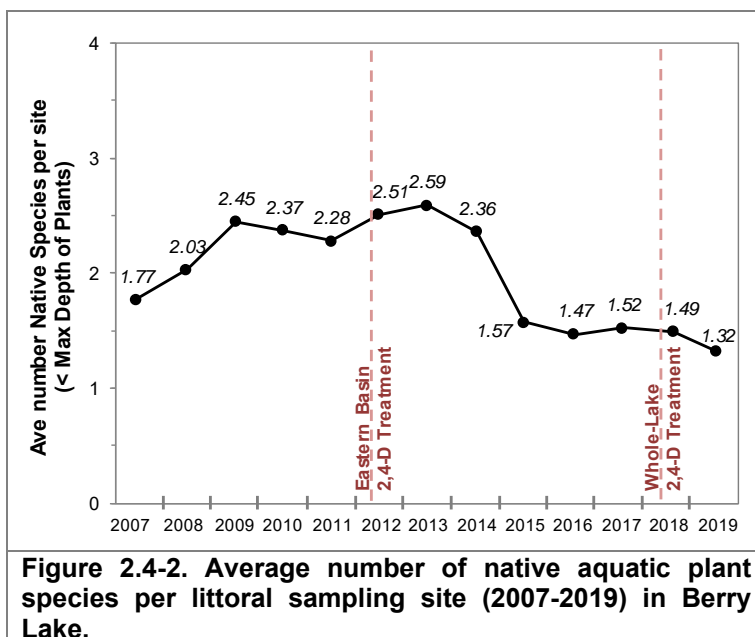
Figure 2.4-2. Average number of native aquatic plant species per littoral sampling site (2007-2019) in Berry Lake.

Figure 2.4-2 investigates the average number of native plant species at each point-intercept sampling location. These data show a reduction in this metric between 2014 to 2015 when no chemical treatment or hand-harvesting occurred. Rising water levels in Berry Lake around the same time frame are thought to be a factor that may influence the native plant populations. Since 2015, the average number of native species per site has remained fairly steady. Following the whole-lake herbicide treatment in spring 2018, the average number of native species remained approximately the same as the previous few years. The 2019 survey found 1.32 native plants per sampling site which is slightly lower than 2018, and is lower than any other year since monitoring began in 2007.

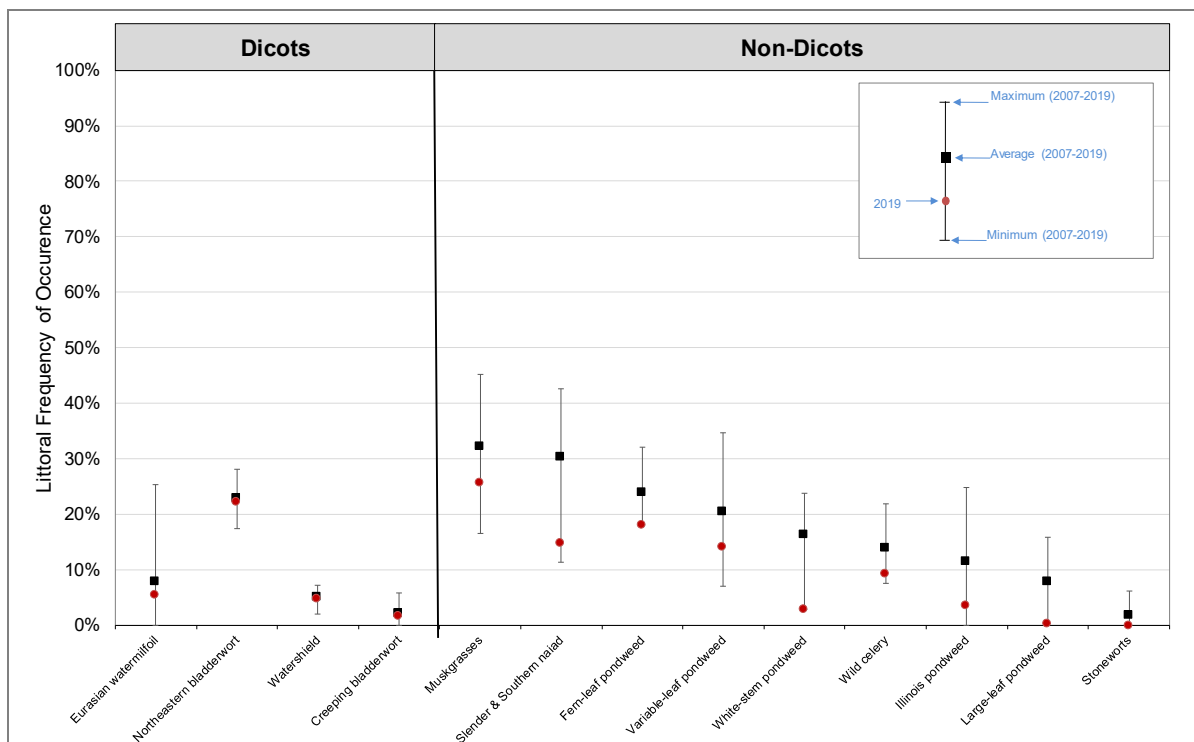
Figure 2.4-3. Historic average aquatic plant frequencies (2007-2019) in Berry Lake. Square symbol represents mean frequency of occurrence, error bars represent range of annual frequencies, red circle symbol represents 2019 frequency of occurrence. Only species with a mean frequency of occurrence $\geq 2\%$ are shown.

Based upon the point-intercept surveys conducted between 2007-2019, Figure 2.4-3 shows mean littoral frequency of occurrence of each species (square black symbol), the population range (extent bars), and the 2019 littoral frequency of occurrence (red circle). The 2019 frequency of occurrence of several of the non-dicot species are lower than the mean values and towards the lower end of the population range.

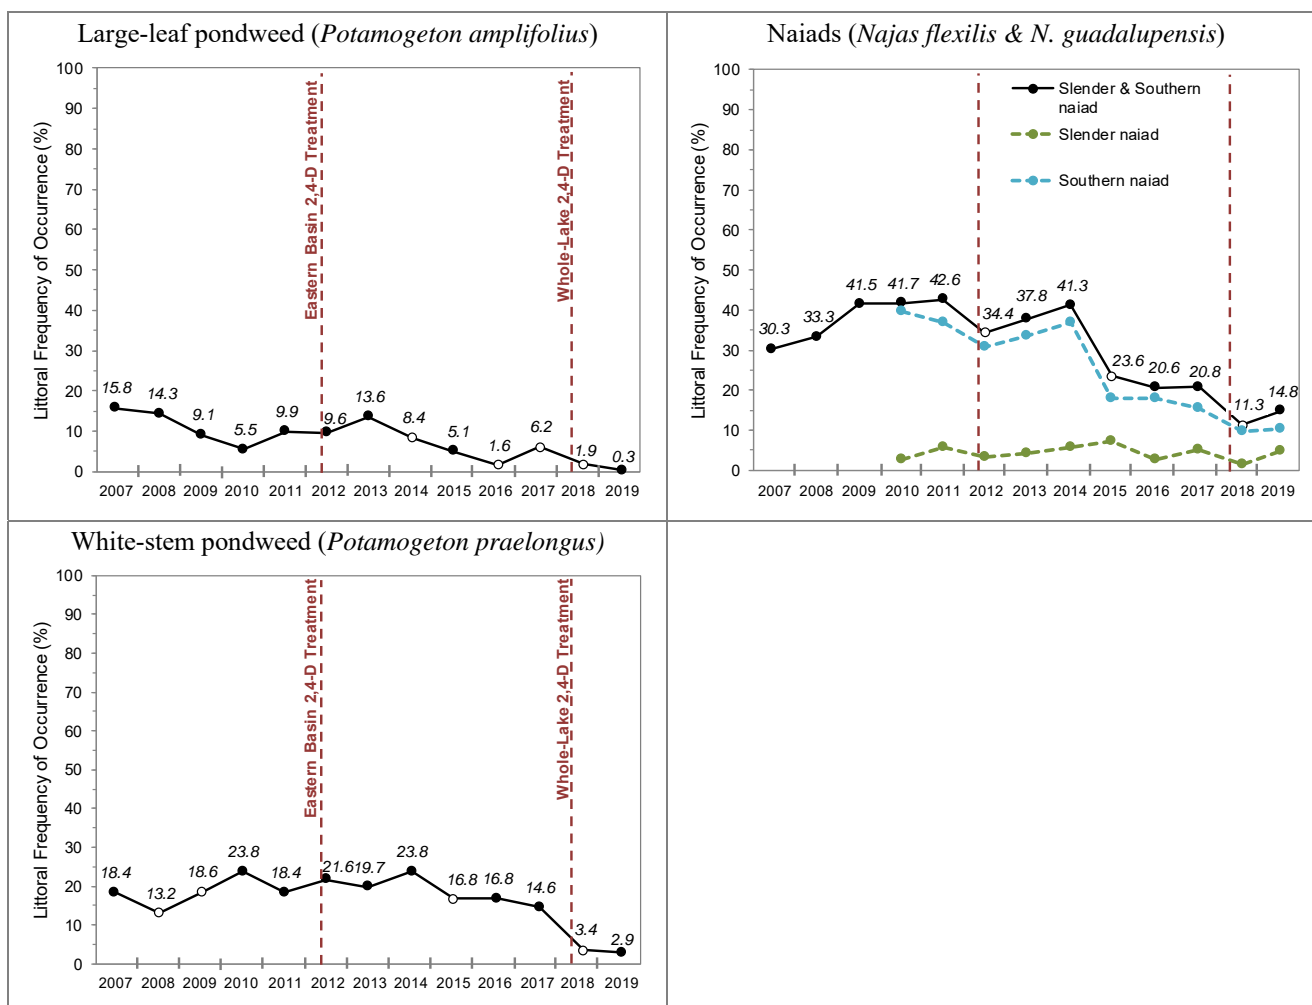
Figure 2.4-5. Littoral occurrence of native species that exhibited a statistically valid decrease in occurrence between 2017-2018 in Berry Lake. Open circle represents a statistically valid change in occurrence from previous survey (Chi-square $\alpha = 0.05$).

Figure 2.4-5 displays the littoral occurrence of native species that exhibited a statistically valid decrease in occurrence between the 2017 and 2018 surveys in Berry Lake which corresponds to the timing of the most recent whole-lake herbicide treatment. Three species, white-stem pondweed (-76.4%), large-leaf pondweed (-69.5%) and the collective occurrences of slender and southern naiad (-45.7%) exhibited statistically valid declines in littoral frequency of occurrence between 2017 and 2018. Continued monitoring in 2019 indicates that the occurrence of large-leaf pondweed and white-stem pondweed decreased slightly compared to 2018, however the difference was not statistically valid. There was a modest increase in the collective population of slender and southern naiads from 2018-2019.

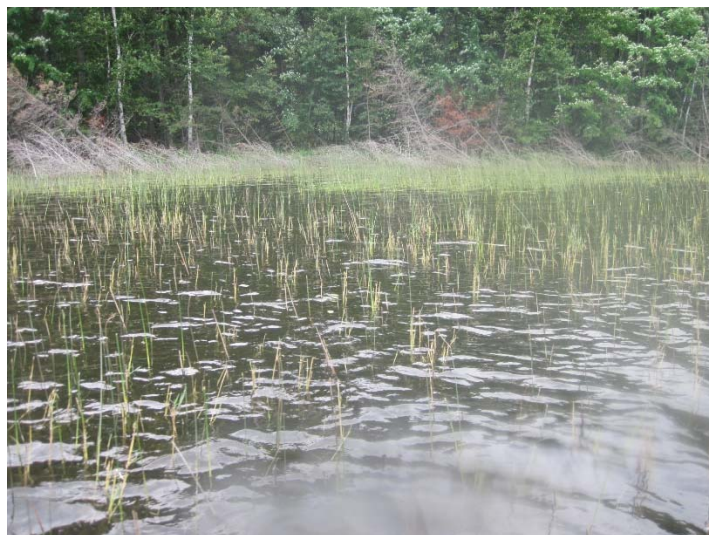
Photo 2.6-1. Common Reed (*Phragmites australis*) observed growing in Berry Lake during a 2018 survey.
(Photo by Onterra, LLC)

The BLPOA partnered with the WDNR through a program conducted under a Great Lake Research Initiative (GLRI) grant to help control common reed populations along the Lake Michigan shoreline, which includes Oconto County. Onterra conducted a survey of the giant reed locations during the summer of 2016 and forwarded the information to the WDNR. Following the appropriate notifications and obtaining landowner permissions, common reed control actions, were implemented by a licensed applicator at forty-five sites on Berry Lake in 2016. No *Phragmites* control efforts were completed in 2017; however, the population was monitored through a late-summer mapping survey that found three locations in the lake, indicating that past control efforts coupled with rising water levels may have contributed to the decline in this species. The common reed population was monitored again in the late-summer of 2018 when Onterra crews mapped all locations during an August visit (Photo 2.6-1).

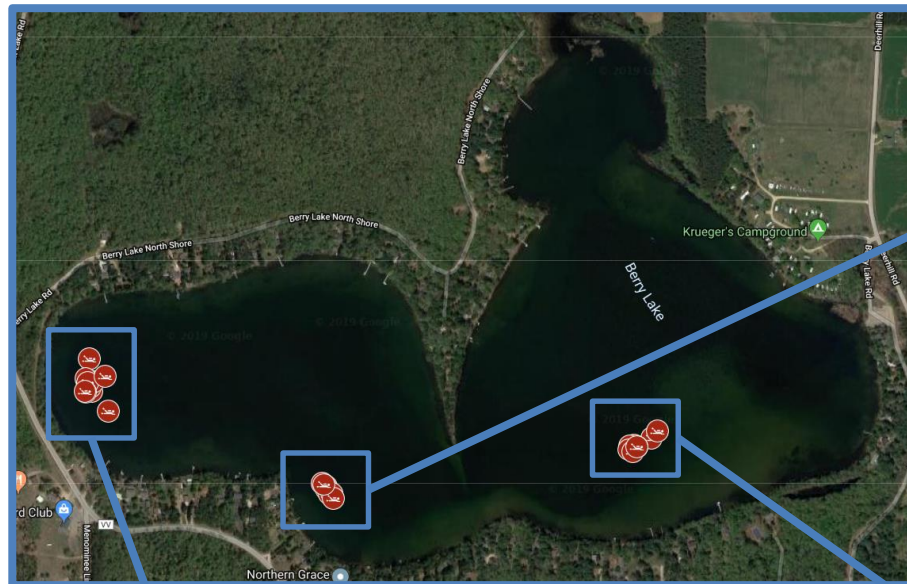
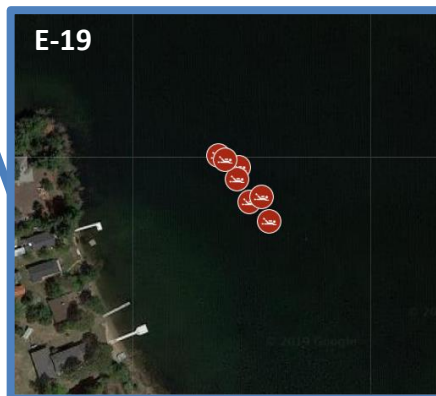
Map of Berry Lake Dive Sites

Recommendations: The HWM on Berry Lake consisted of relatively short plants over multiple different dive locations, however DASH was an effective method to target the denser areas of plants that were prioritized by the Berry Lake Property Owners Association. The Berry Lake Property Owners Association should continue to closely monitor the HWM growth over the course of the summer in order to determine if any new or regrowth occurs in the targeted areas.
